# 1. HERITAGE STRUCTURES NOTES

*The following material is a brief review of heritage principles as relevant to courses in the School of Civil Engineering in the University of Sydney. Reproduction of the external references contained herein is covered by the teaching provisions of the Copyright Act of Australia (Part III). It must also be emphasised that the copyright of the respective items continues to be held by the authors or publishers as clearly indicated and such copyright must be respected, even if free download is encouraged by the authors. IGB*

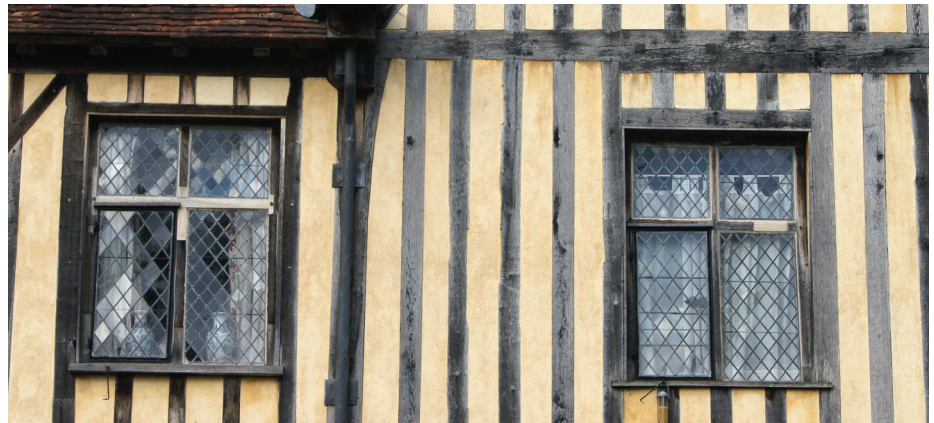
**Figure 1**  
Timber window repairs at Ightham Mote demonstrate decision-making based on retention of original fabric

Many years ago, in the 1980s, the author was looking up at window joinery repairs at Ightham Mote, a 14th century property belonging to the National Trust in the UK. Short sections of oak transom had been pieced into the middle of the frames and short ends of the stiles replaced (Figure 1). They stuck out visually, attracting comment. Why keep the old? Why not just replace whole lengths or even the whole casement? Surely this is better in the long run?

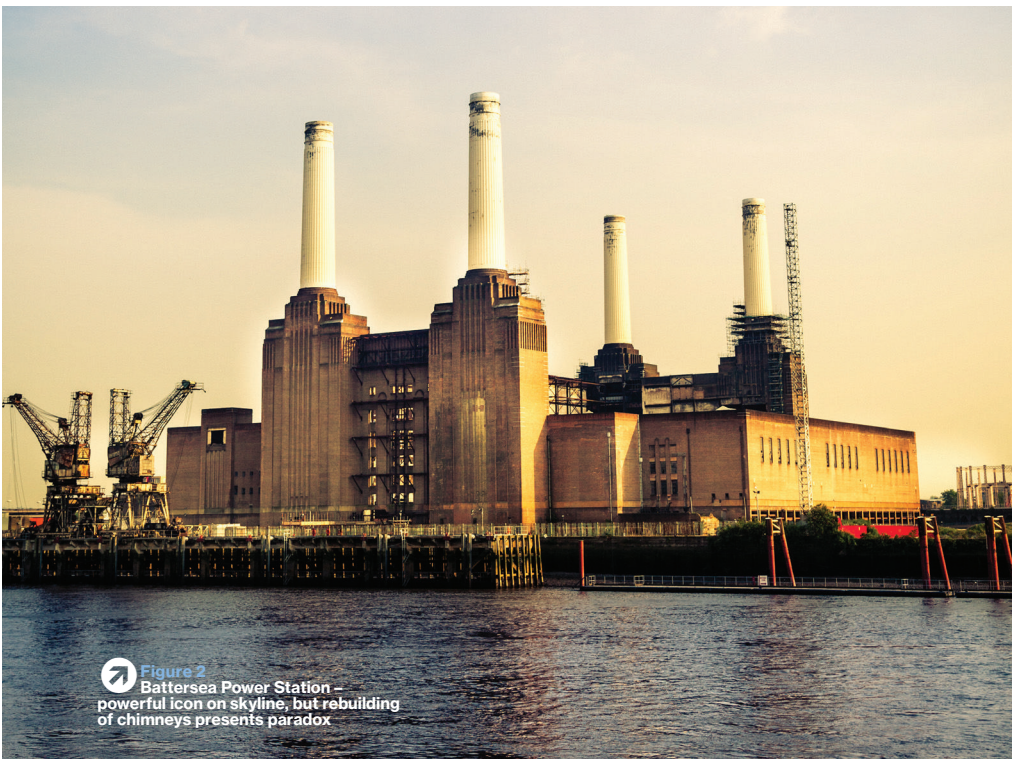
**Figure 2**  
Battersea Power Station – powerful icon on skyline, but rebuilding of chimneys presents paradox

Another powerful London icon – and one that is surely controversial to many, engineers and others alike – is the Grade II listed Battersea Power Station (Figure 2). What societal values are being balanced when a

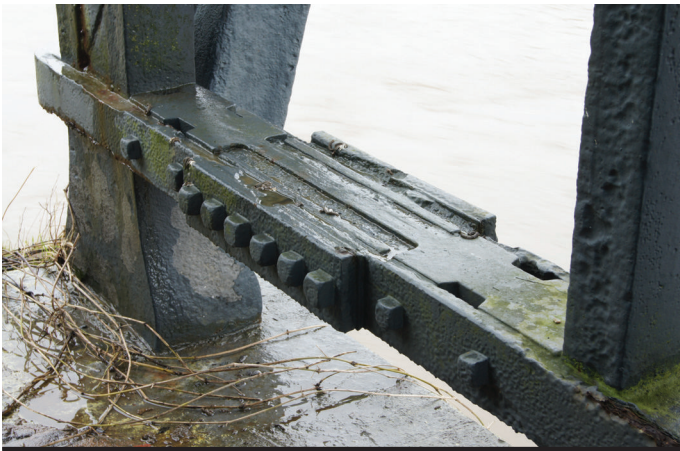
**Figure 5**  
Iron Bridge, Shropshire. Intervention from 1902, providing greater integrity by tying together lower ends of five arches. In cast iron and mild steel, representing best practice at time

The Iron Bridge in Shropshire is both a remarkable example pioneering the use of materials and a global icon. However, like many pioneering structures it has suffered from defects: in this case being highly redundant, unable to accommodate movement in the abutments and now exhibiting over 100 cracks to the cast ironwork (Figure 5). These defects have appeared progressively throughout its life, and each received the attention of some of the finest engineers of their age: probably Thomas Telford in 1801, certainly Sir Benjamin Baker in 1902 and Sir Basil Mott in 1923. What results is honesty, not something hidden or in replica: an authentic patina of alterations and repairs. Although the work predates the modern conservation movement and the development of philosophies, almost all repairs are reversible<sup>10</sup>.

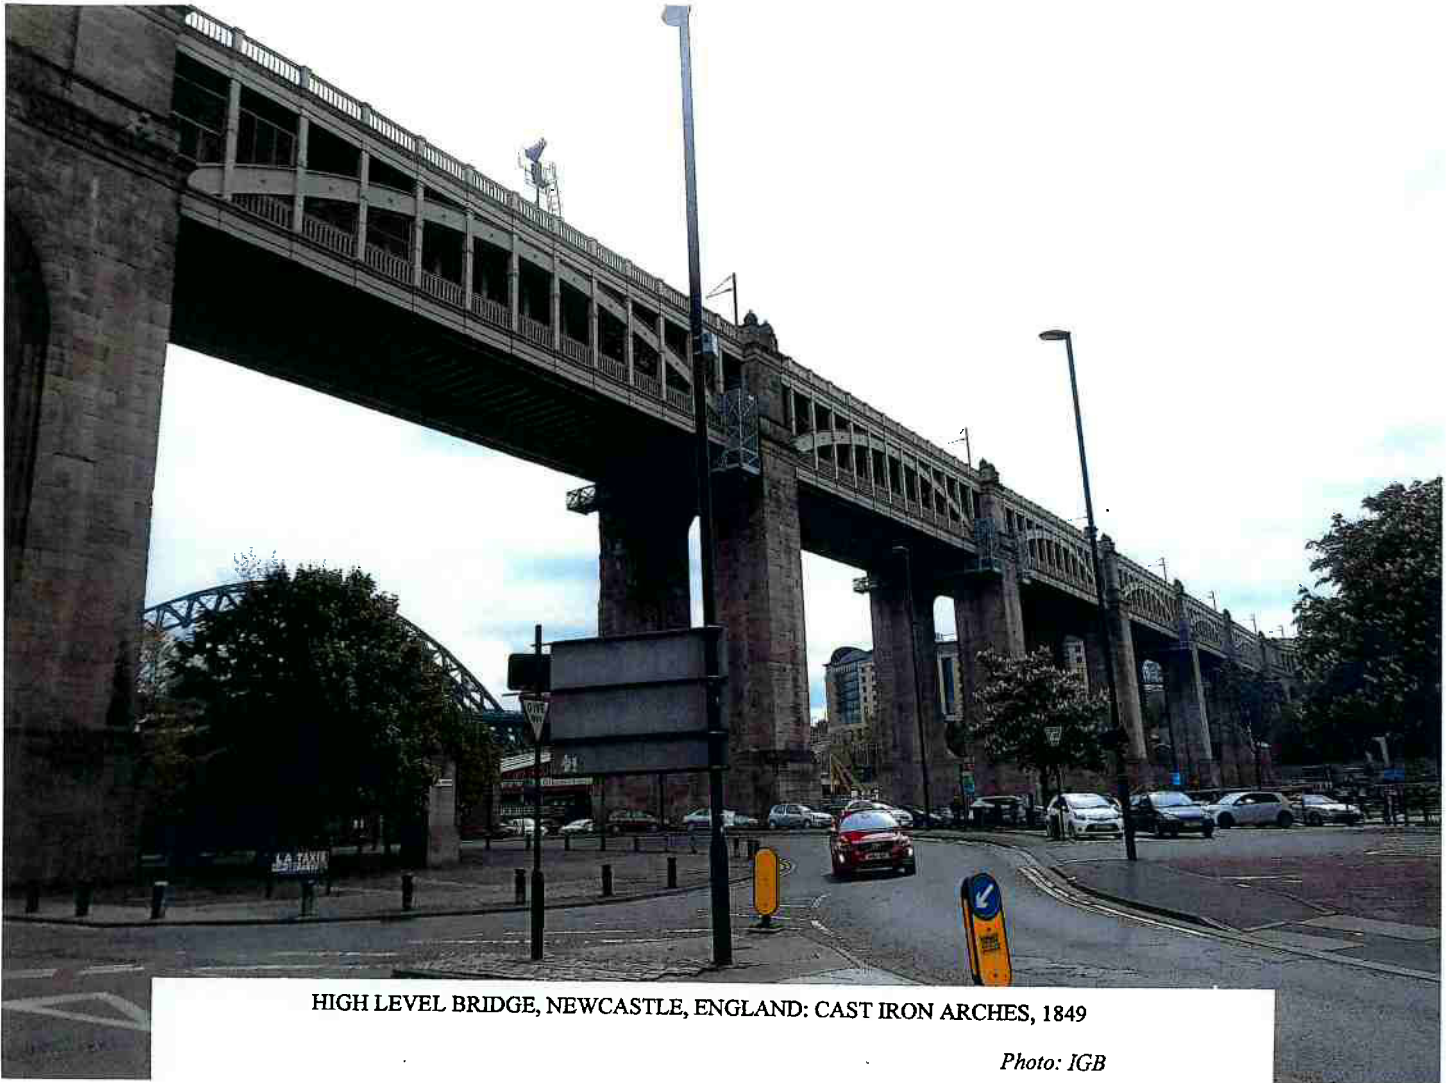
**HIGH LEVEL BRIDGE, NEWCASTLE, ENGLAND: CAST IRON ARCHES, 1849**

The inevitable deterioration of this structure since 1849 has, perhaps not unexpectedly, affected the main arches – in compression – the least. (The wrought iron tie chains for the arches were attacked by corrosion due to bad drainage, as similarly the wrought iron hangers supporting the road deck from the arches.) Cast iron girders for the road and rail decks which, of course unlike the main arches involve tensile stresses, deteriorated under fatigue and so much remedial work has been required. Fatigue tests have been carried out on some of these girders and strengthening or replacement has taken place. The accumulation of information

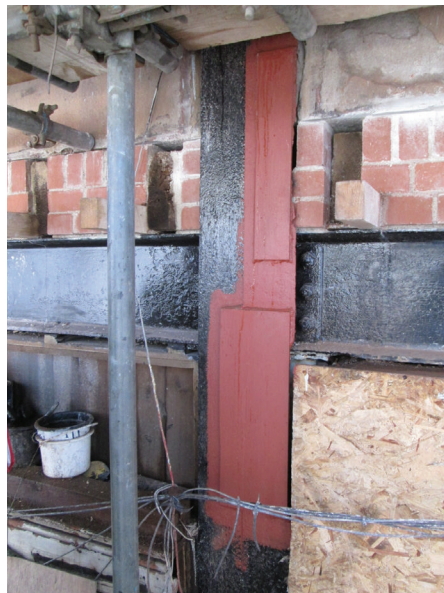
**Figure 2**  
Cast iron column, complete with cast Corinthian capital

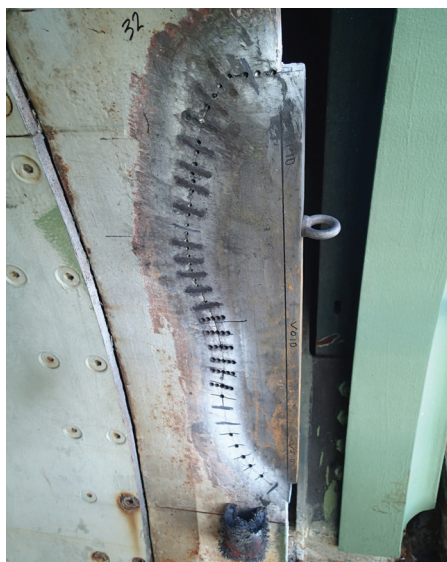
Figure 3  
Example of cold stitching

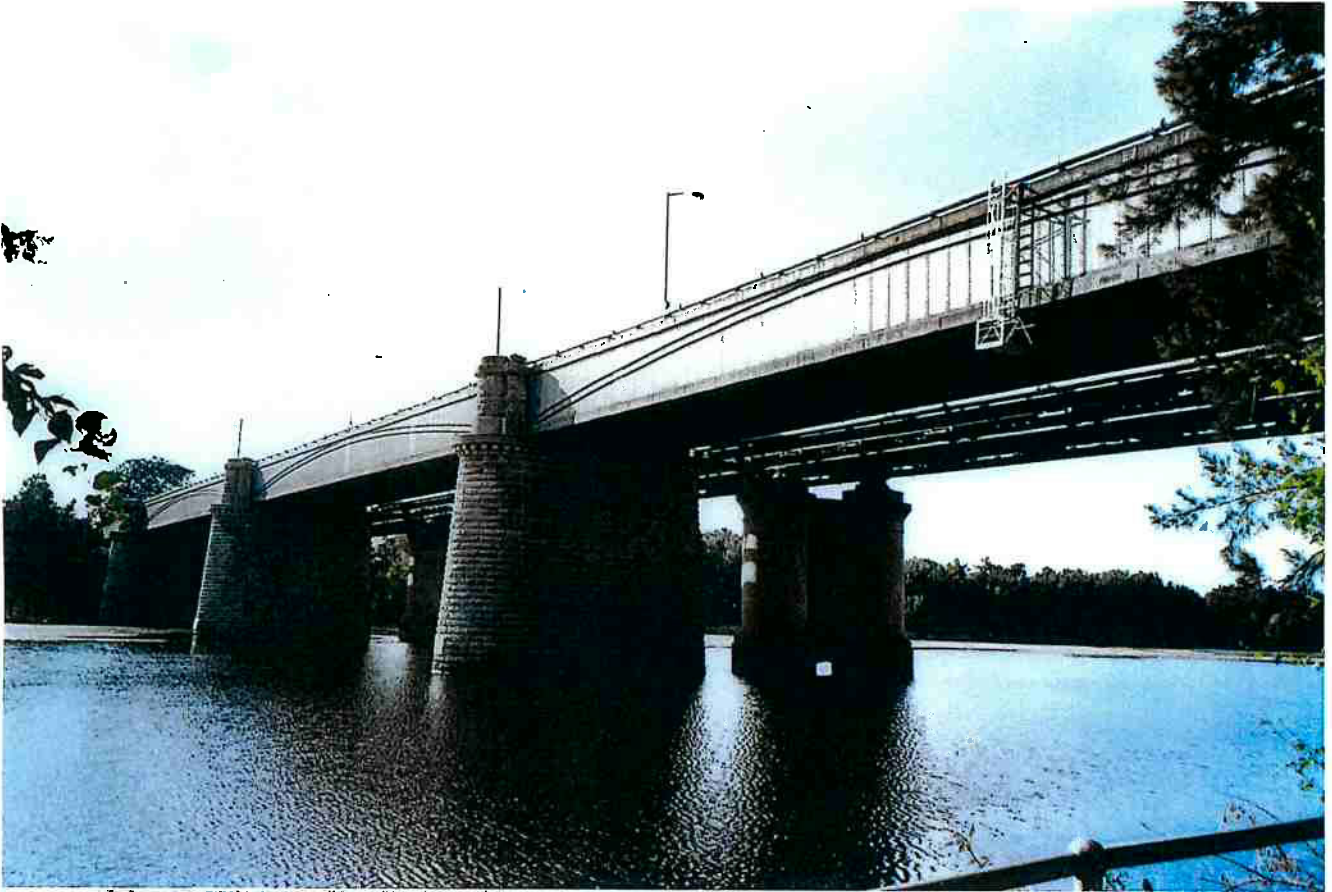
VICTORIA BRIDGE, PENRITH, NSW: WROUGHT IRON BOX GIRDERS, 1867

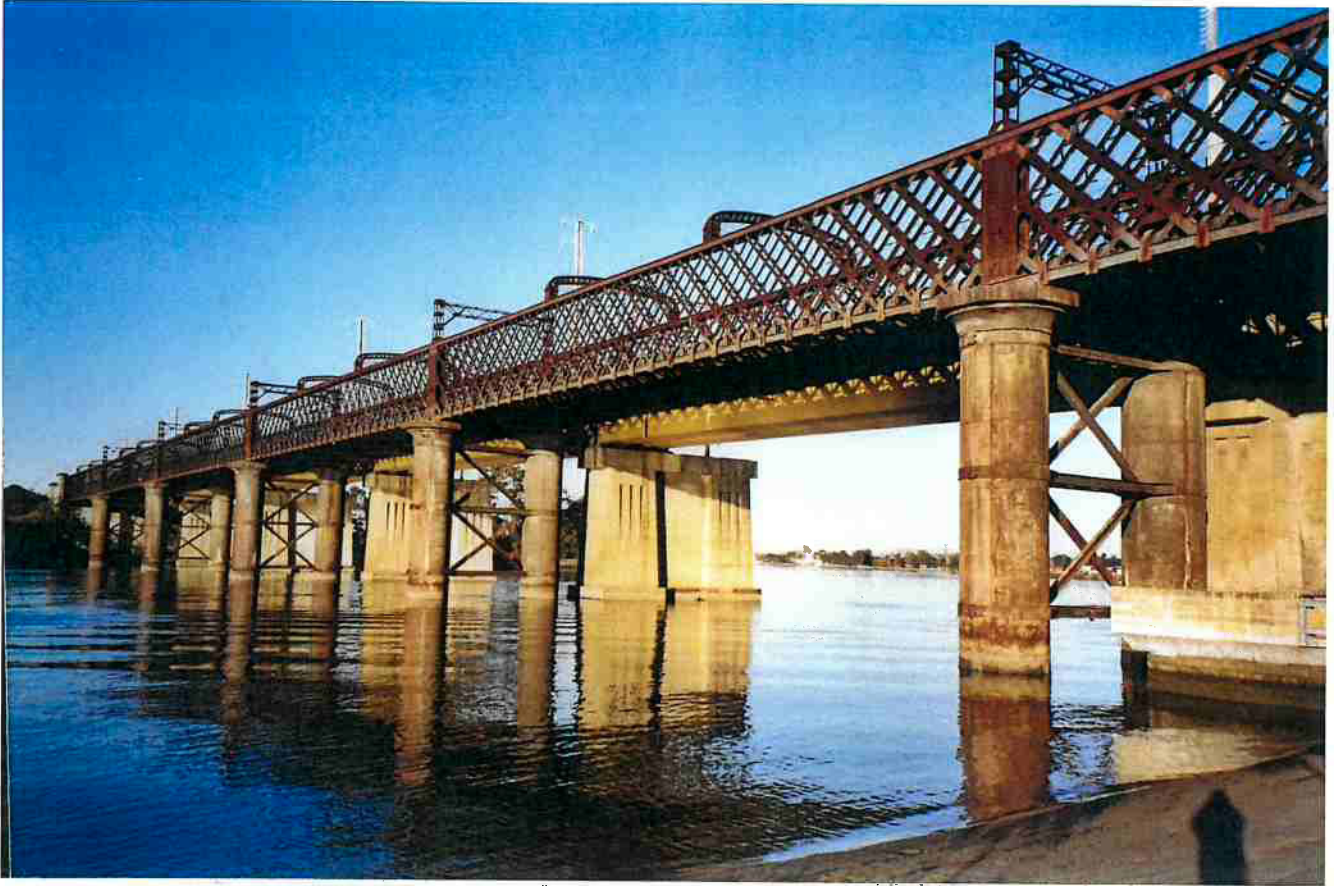
MEADOWBANK RAILWAY BRIDGE, NSW: WROUGHT IRON LATTICE SPANS 1886

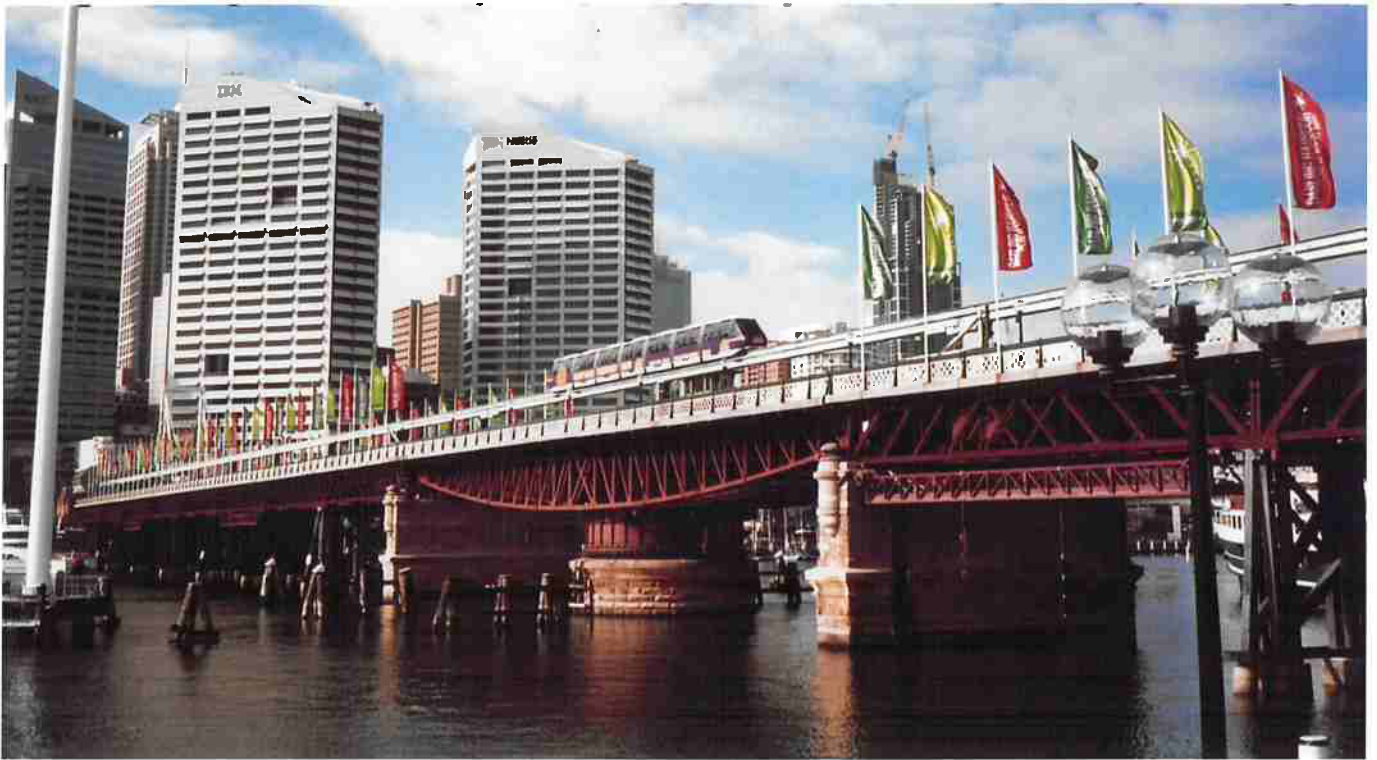
**PYRMONT BRIDGE, SYDNEY: STEEL SWING SPAN/TIMBER TRUSS  
APPROACH SPANS, 1902**

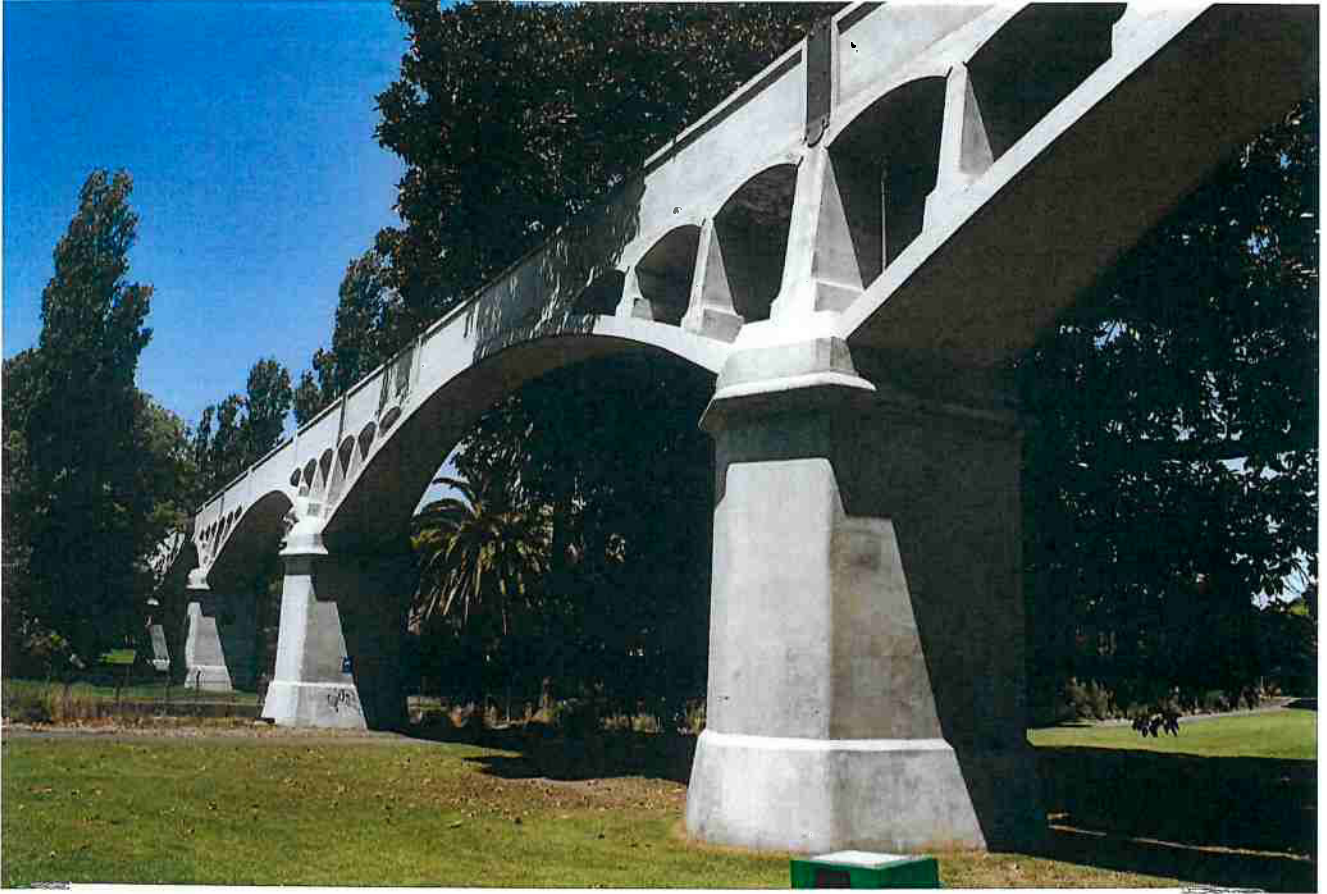
ANNANDALE SEWER AQUEDUCTS: REINFORCED CONCRETE ARCHES, 1896

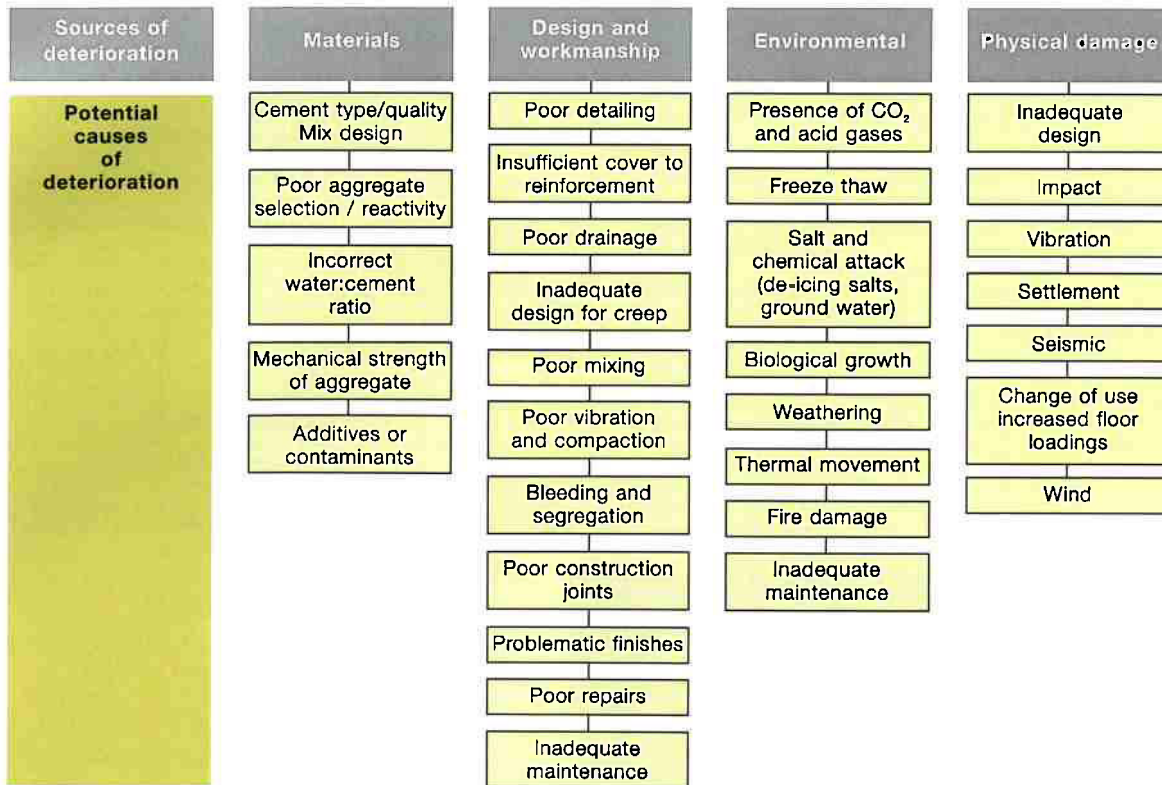
The principal sources and causes of concrete deterioration.  
Table by Susan Macdonald

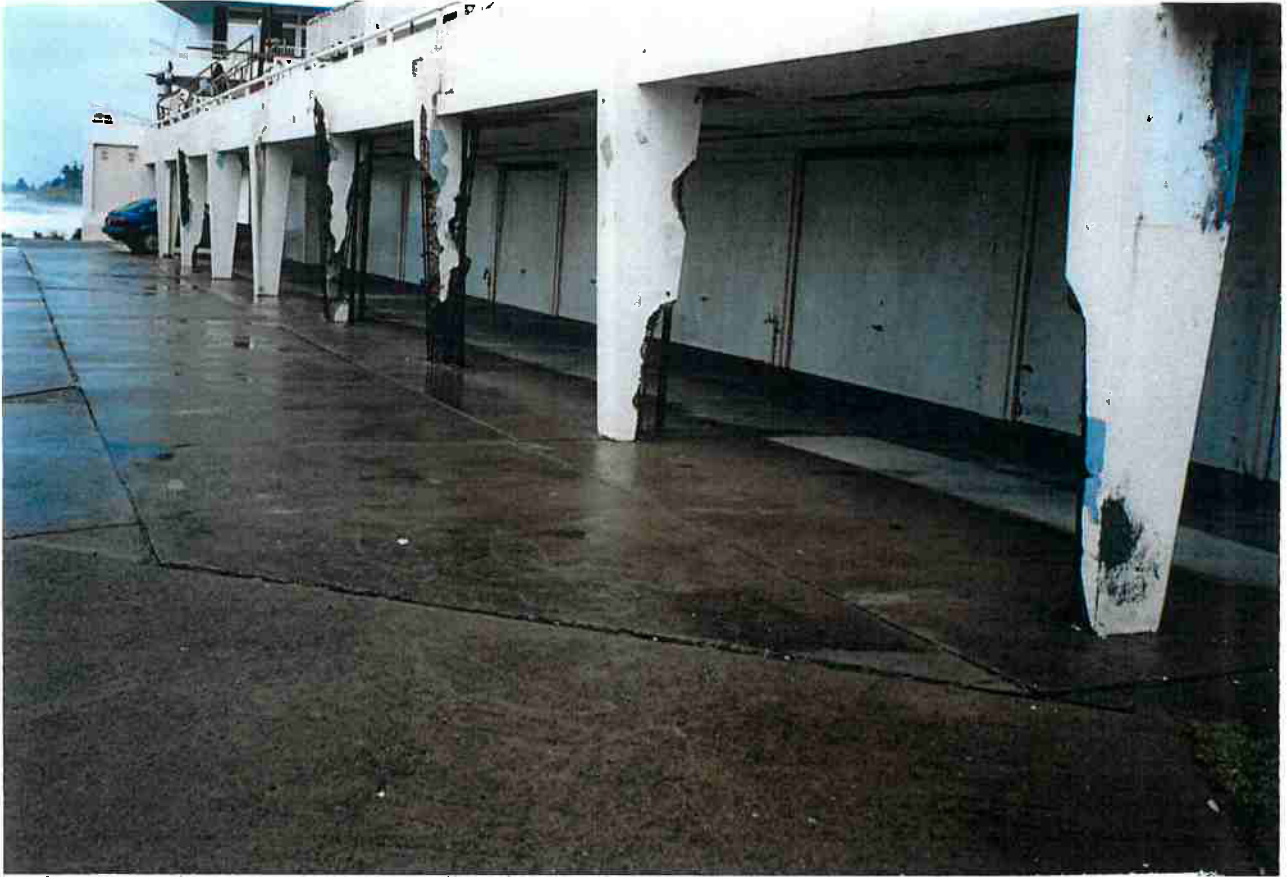
COLLARROY BEACH APARTMENTS, SYDNEY: REPAIR OF CONCRETE

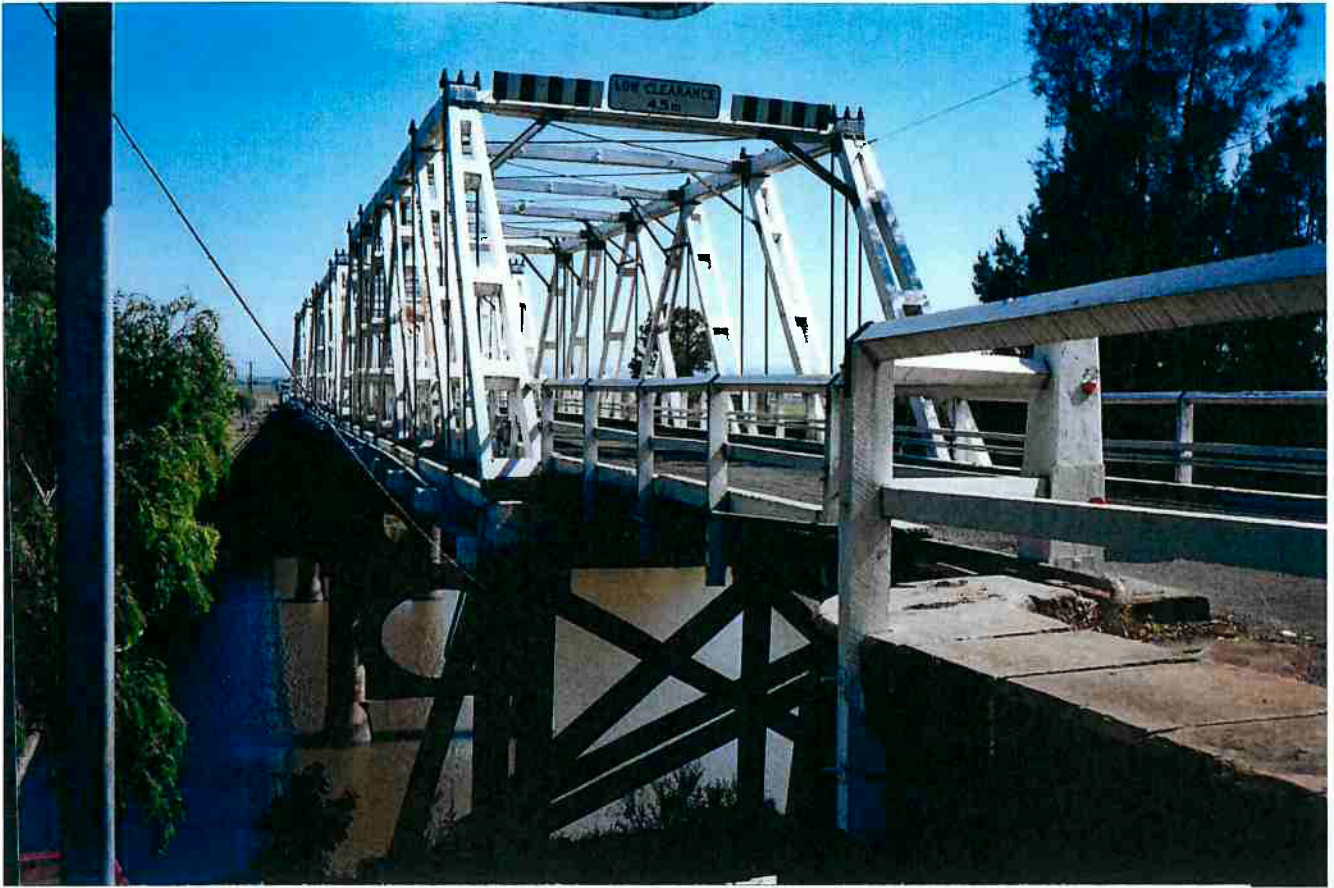
MORPETH BRIDGE, NEW SOUTH WALES: TIMBER ALLAN TRUSSES. 1898

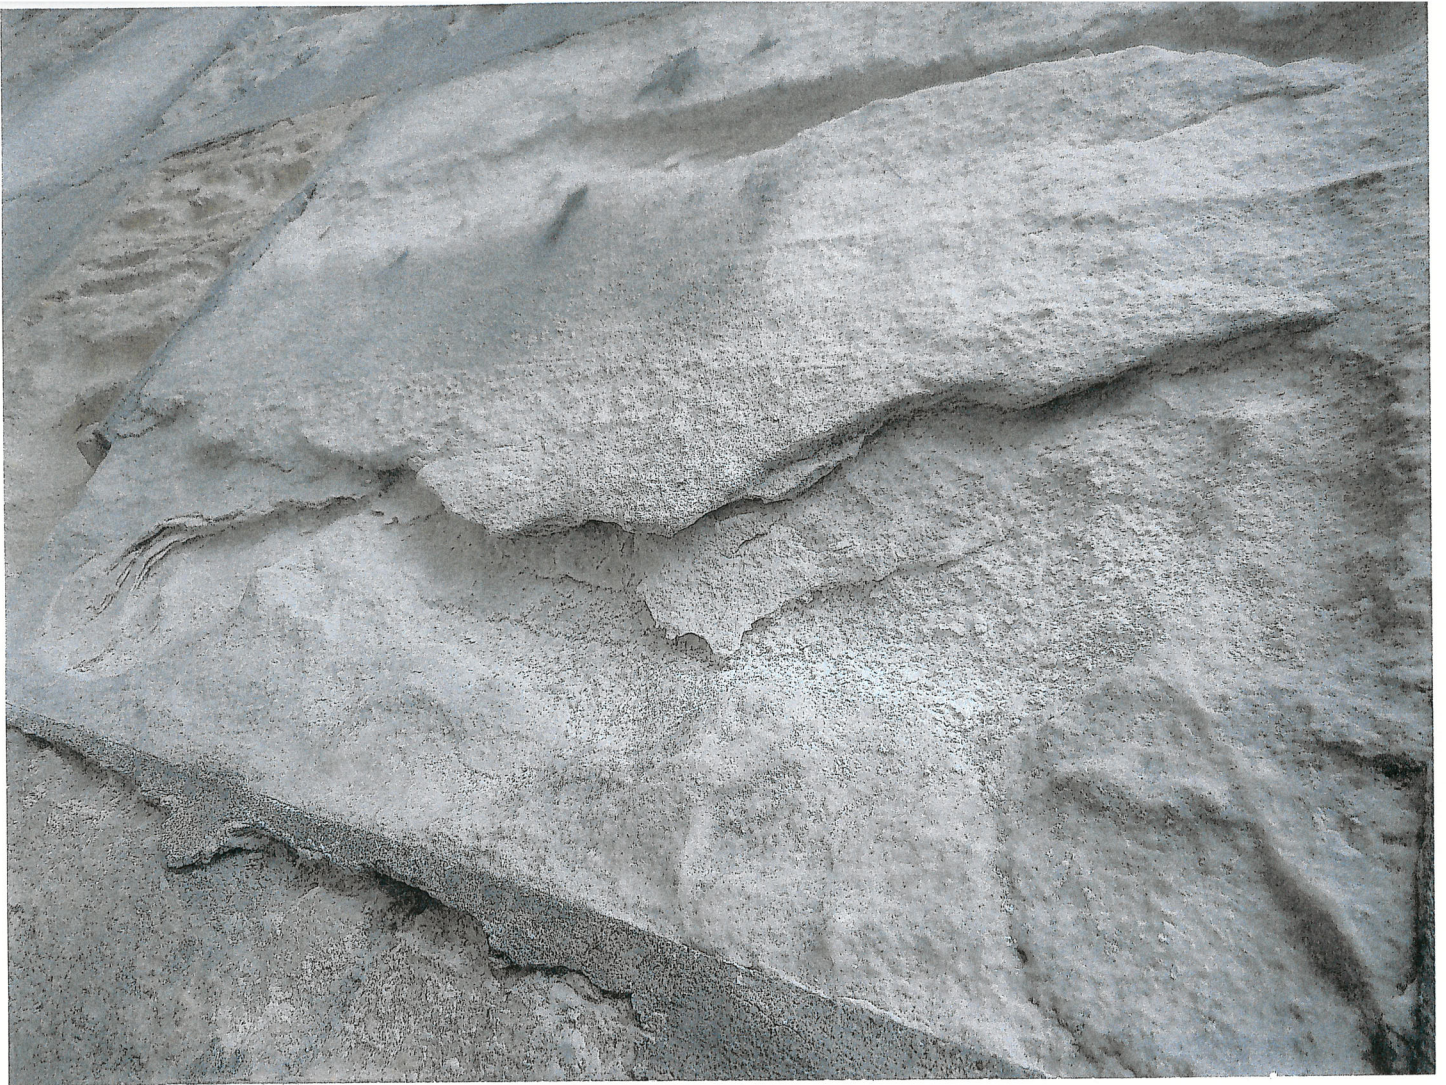
LAMINAR DETERIORATION OF MAGNESIAN LIMESTONE, YORK MINSTER, UK

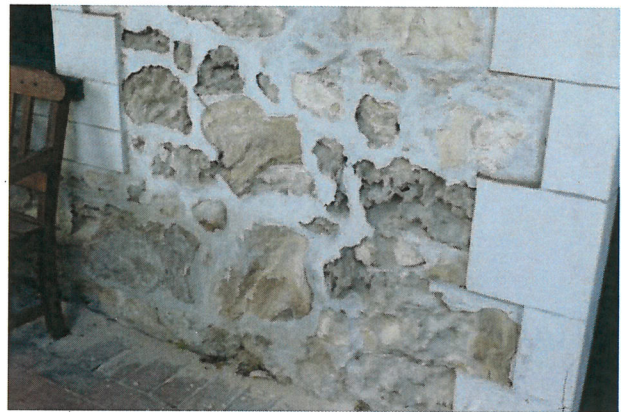
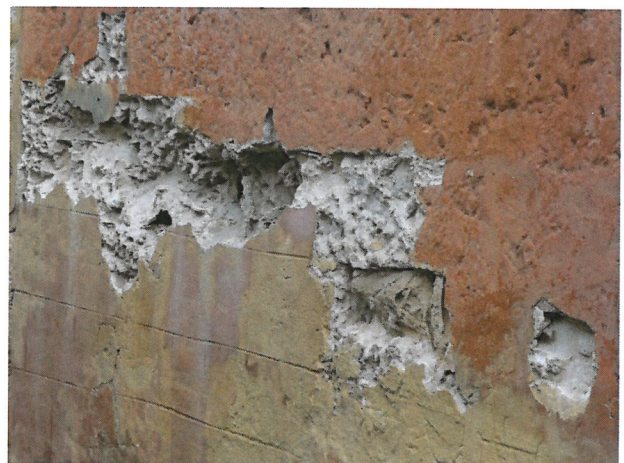
*Two examples of the decay caused by impermeable cement mortar, which forces the limestone walls to dry through the stones. Salts accumulate in the stones which erode away, leaving the mortar standing proud. It's much cheaper and easier to replace mortar (repointing) than it is to replace stone.*

This effect can be seen in many walls that have been repaired with the best of intentions, but using the wrong materials. The new cement mortar stands proud while the stones erode (or fret) back from the surface leaving deep cavities. Eventually the stones will need replacement, which will be much more costly than replacing the mortar.

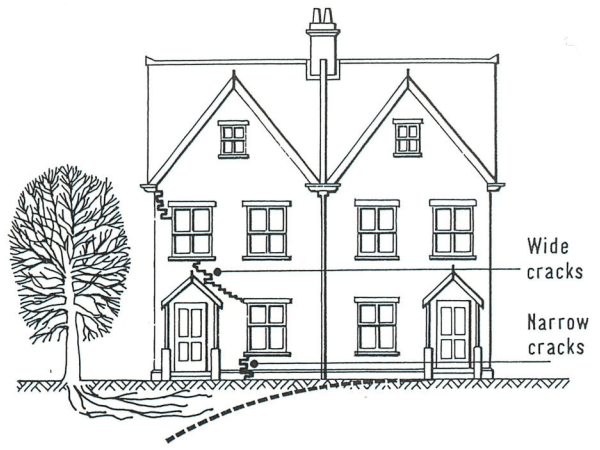
(b) Local settlement

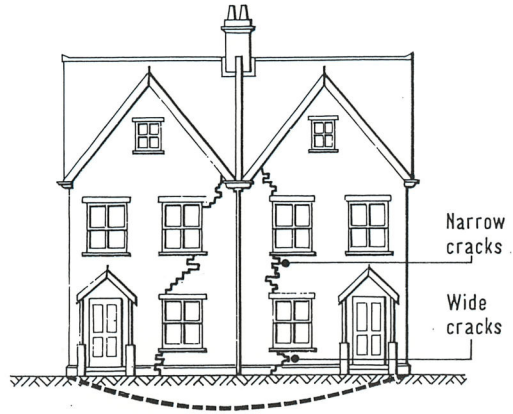
(c) Sagging

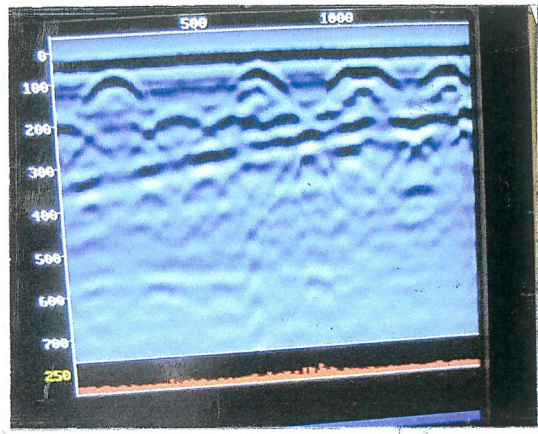
*Hyperbolae images on "point"/finite objects*
